## 38 Year-Old Construction Laborer Dies When Trench Walls Collapse

Kentucky Case Report: 03KY107

Date of Incident: November 3, 2003

Report Release Date: November 5, 2004

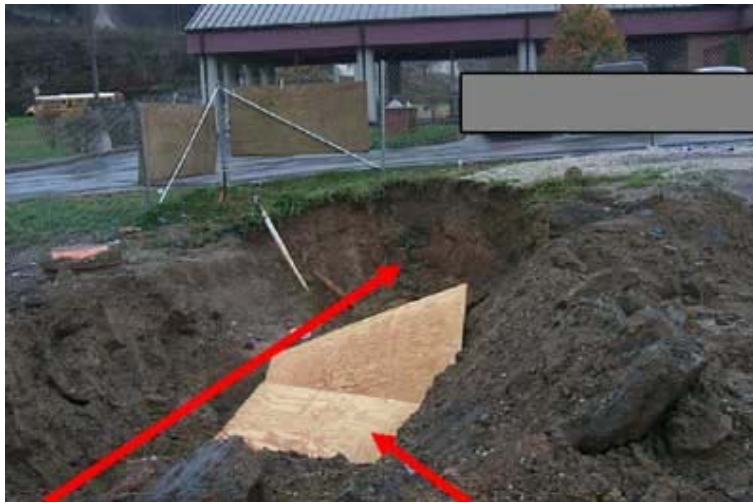
At 11:15 am, the superintendent and the subcontractor's foreman were at the boundary line next to the trench where the work crew had worked in since Thursday. The two men determined the location where the old abandoned gas pipe was to be cut off at the boundary line. After this decision was made, the superintendent returned to the trailer and the foreman proceeded to operate a track hoe and excavate to dig a 6 foot wide x 8 foot deep x 16 foot long trench from the end of Thursday's trench to within 4 feet of the boundary line and fence. This trench was within 10 feet of the heavily trafficked driveway which served the two neighboring businesses. No sloping or benching methods or shoring equipment were used in the trench. Instead, the sides of the trench, sheared by the teeth of the track hoe, were straight down. After the trench was dug by the foreman, he moved the track hoe to the far end of Thursday's ditch (see [Diagram](#)). The victim jumped in the hole with a saw and proceeded to cut through the gas line and casing (making this cut should have only taken a minute). While the laborer was cutting through the gas line and casing the sides of the trench caved in, burying him.

Location of victim in trench when sides collapsed.  
Plywood used by emergency response personnel.

According to one person interviewed, the decedent's job of cutting the exposed gas line pipe and casing with a saw should have only taken a few minutes to accomplish. Taking the time to shore the sides of the trench would have taken longer than sawing the pipe and casing. Instead, it was decided to take a shortcut and not protect the laborer from the possibility of the trench sides collapsing.

Employers are required by OSHA Standard 29 CFR 1926.652(a)(1) to protect employees from cave-ins while performing excavation work. This regulation also stipulates configurations for sloping sides of trenches and appropriate materials to be used in shoring walls of excavation sites. Any trench 5 feet or more in depth must have an adequate protection system before being used by employees.

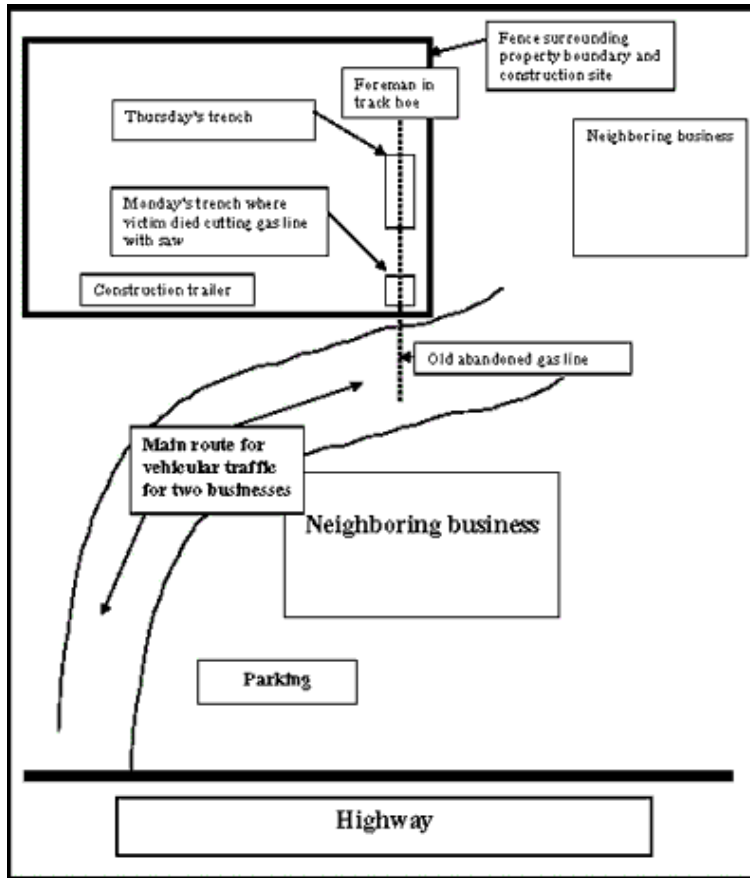
The job site was in a commercial area located behind and to the left of existing businesses (see [Diagram](#)) and was surrounded by chain link fencing. The work was to be performed in a corner where the three properties came together. The two existing businesses shared a driveway which passed from the highway between the business in front and the construction site, around the corner and to the other existing parking lot. Heavy traffic traveled in front of the work site to and from the existing businesses and within 10 feet of the trench where the fatality occurred.

Diagram of construction site and neighboring businesses, driveway and parking lots.
